24 April 2017

**\* IMMEDIATE ATTENTION REQUIRED \***

This notice is to inform AKD owners about a bug in the **Backup FPGA firmware**.

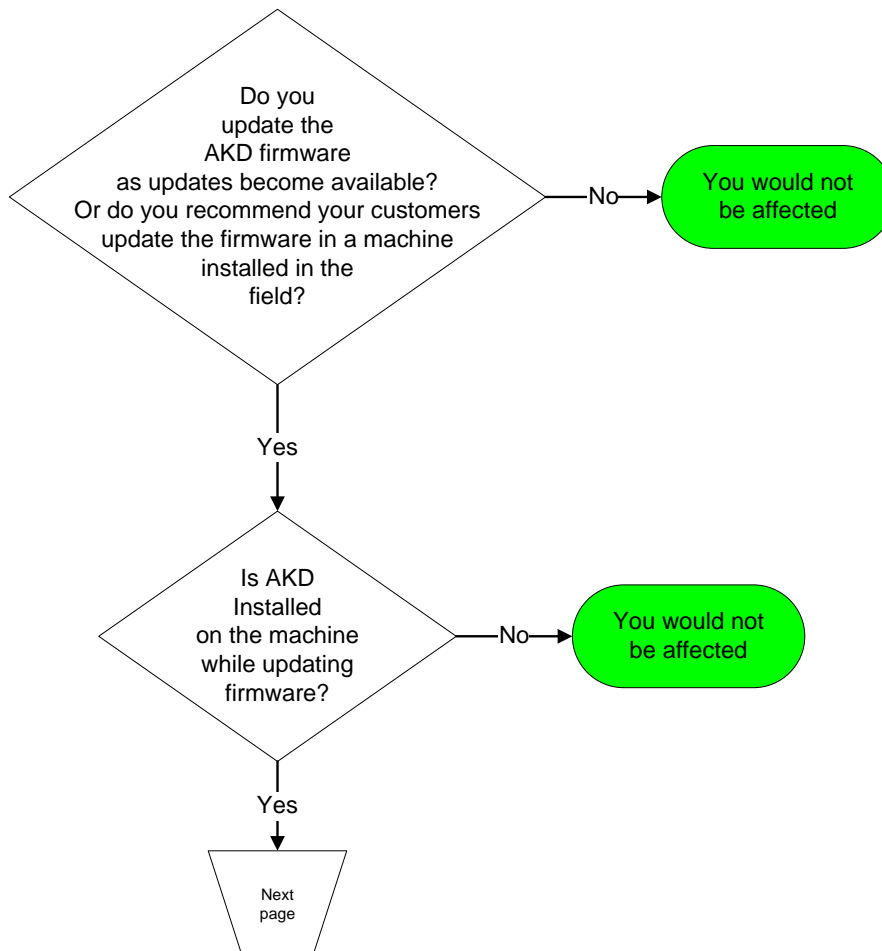
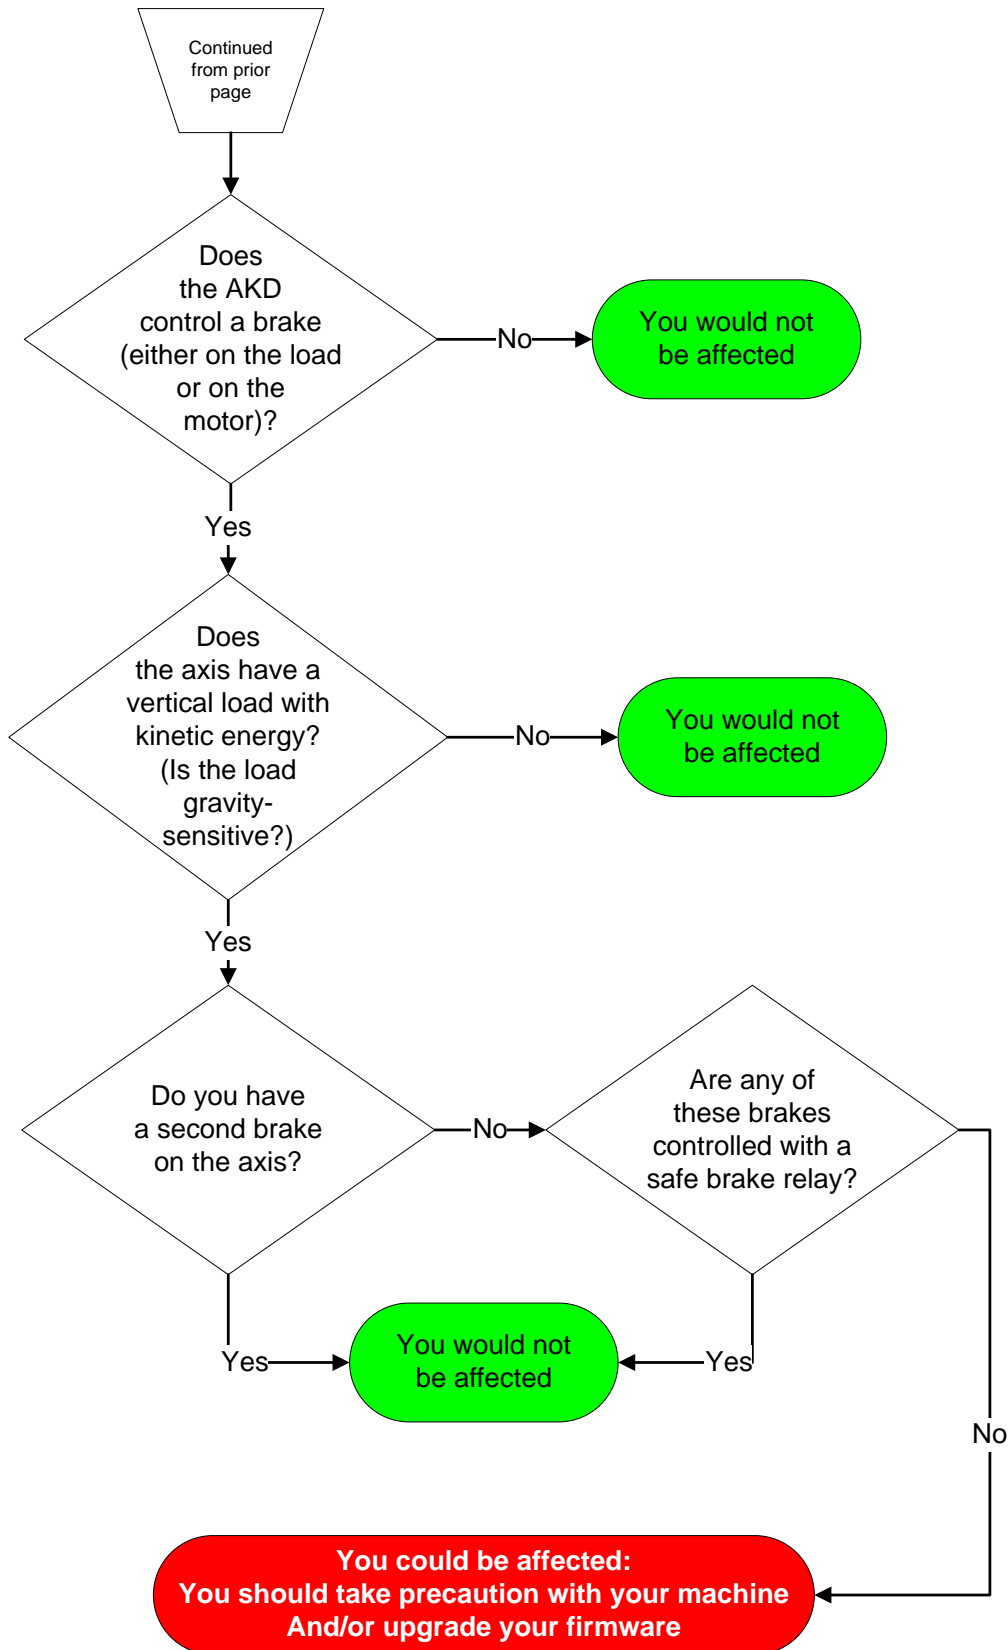
If you are using the affected AKDs listed above, your *application* may or may not be affected by this bug. Please follow this flowchart to check if this bug affects your application:
