## FAILURE ANALYSIS

### UCB2 FAMILY - E102-E104-WATCHDOG

January 18, 2007

| Product Name | CD Series 5<br>PicoDrive Series 5<br>TRMM2 Rack Mount Drive |

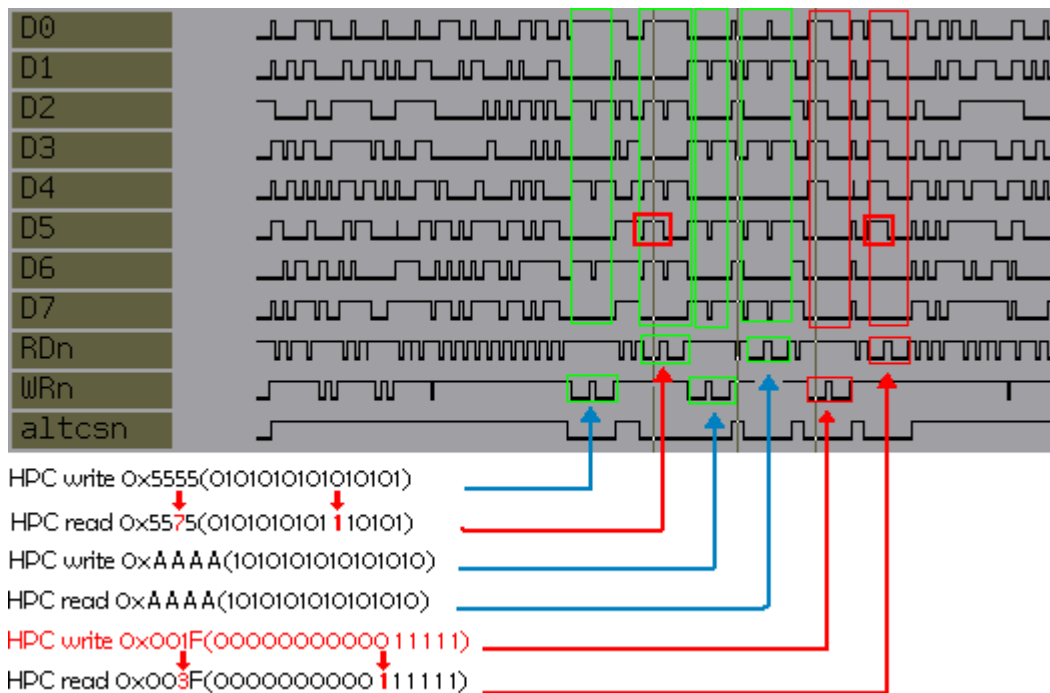
#### Example 1:

In this diagram we can see failure in bit 5.

HPC write 0x5555 to DPRAM and read back 0x5575 instead 0x5555 (bit 5 value is "1" instead "0"). Then HPC write/read 0xAAAA to/from DPRAM. After it HPC add current received value to previous received value (0x5575 + 0xAAAA = 0x1001F) and write calculated value (0x001F) to DPRAM. Then HPC read back value 0x003F with failure in bit 5. HPC complement received value and because of the calculated value greater than ZERO the function was stopping and returned this value. Of course DPRAM validity check failed because of returned value greater than ZERO.

This configuration code compiled by MAXPLUSII software. But when this code compiled by QUARTUSII software the failure disappears.

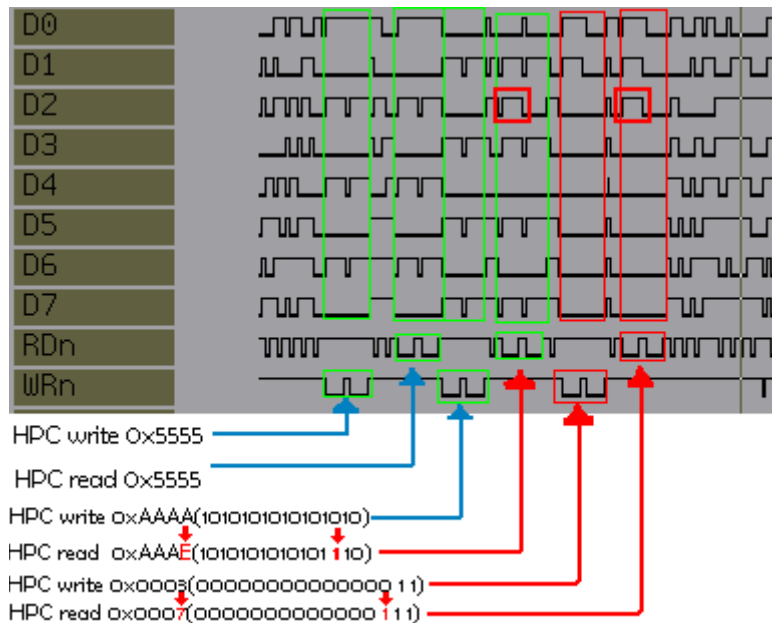
#### Example 2:

In this diagram we can see failure in bit 2.

HPC write/read 0x5555 to/from DPRAM. Then HPC write 0xAAAA to DPRAM and read back 0xAAAE instead 0xAAAA (bit 2 value is "1" instead "0"). HPC add current received value to previous received value ( $0x5555 + 0xAAAE = 0x10003$ ) and write calculated value (0x0003) to DPRAM. Then HPC read back value 0x0007 with failure in bit 2. HPC complement received value and because of the calculated value greater than ZERO the function was stopping and returned this value. Of course DPRAM validity check failed because of returned value greater than ZERO.

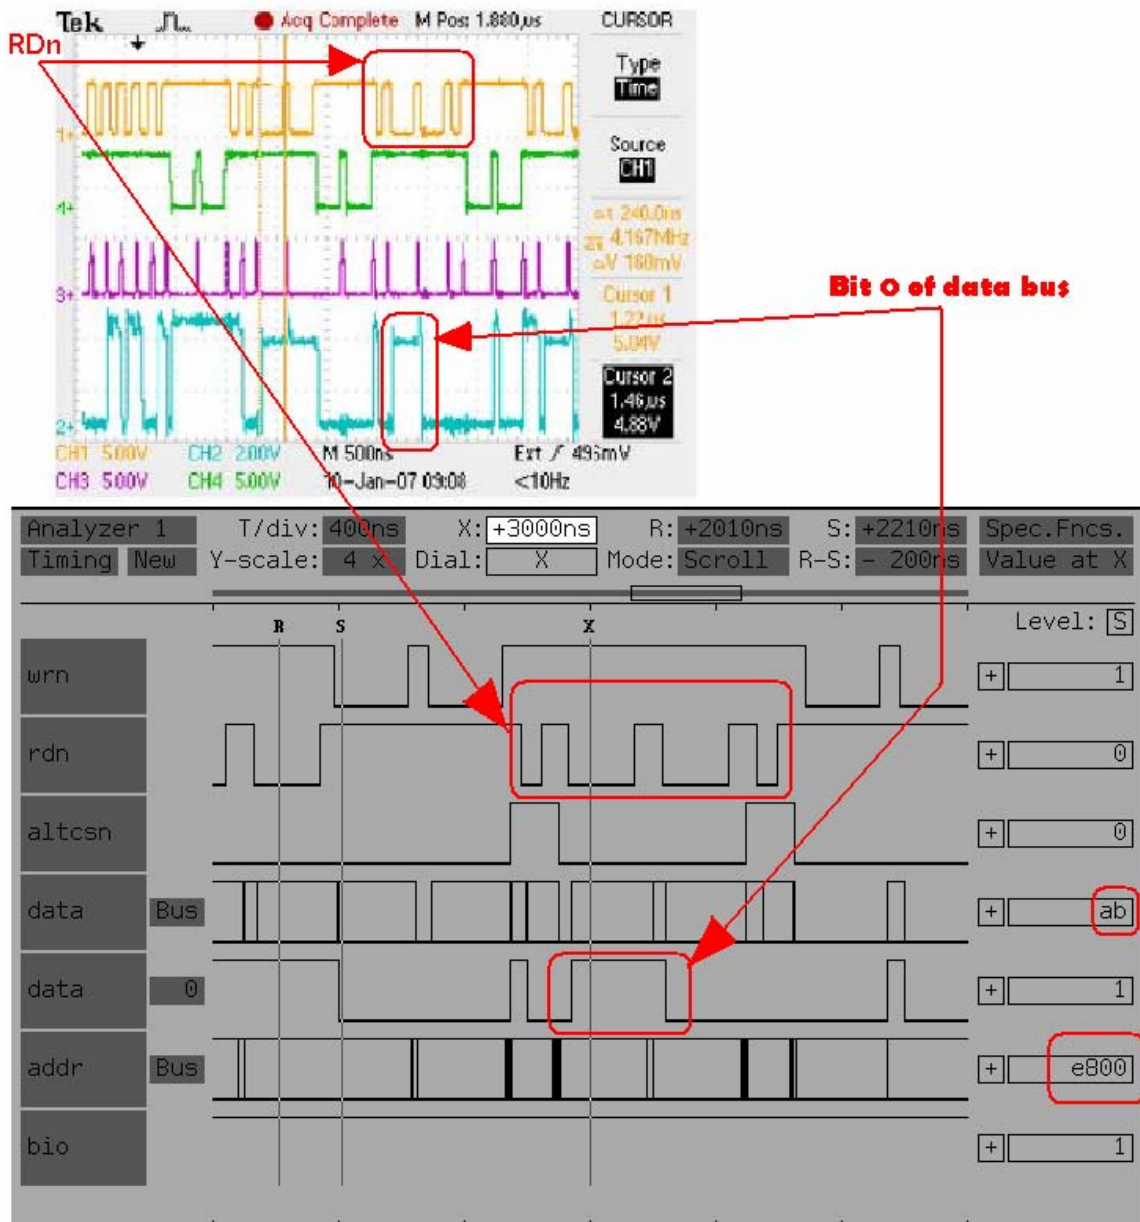
According to Ari's supposition took place Flash ([AM29F800](#)) timing issue because 70ns flash was assembled instead 55ns as planned. But after measurements by Scope&LogicAnalyzer this supposition doesn't true. We can see that signal clear, without collision and stand in RDn time. In bottom picture we can see BIT0 of data bus. This bit create failure in this case.

According to Ari and Boris comments took place Altera's internal timing issue.
