AKD2G EtherCAT synchronization error F7011

Overview

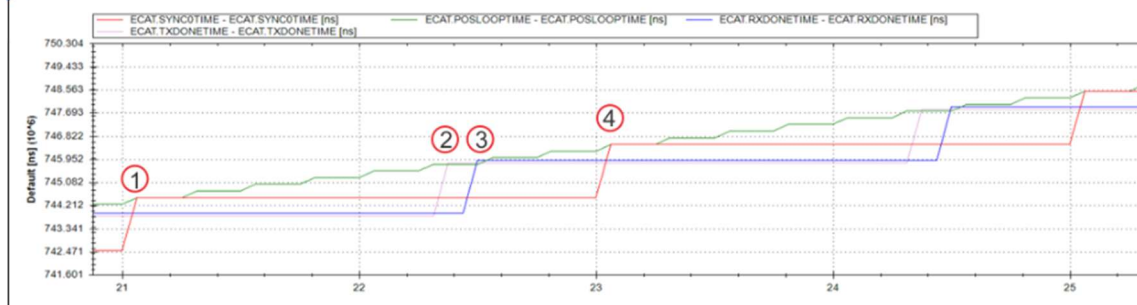
For example here's the timing captured in the Workbench Scope.

Note: It's important the drive's CANOPEN.SAMPLEPERIOD is set equal to the master's bus rate.
