## FAILURE ANALYSIS

### UCB2 FAMILY - E102-E104-WATCHDOG

January 18, 2007

| Product Name | CD Series 5<br>PicoDrive Series 5<br>TRMM2 Rack Mount Drive |

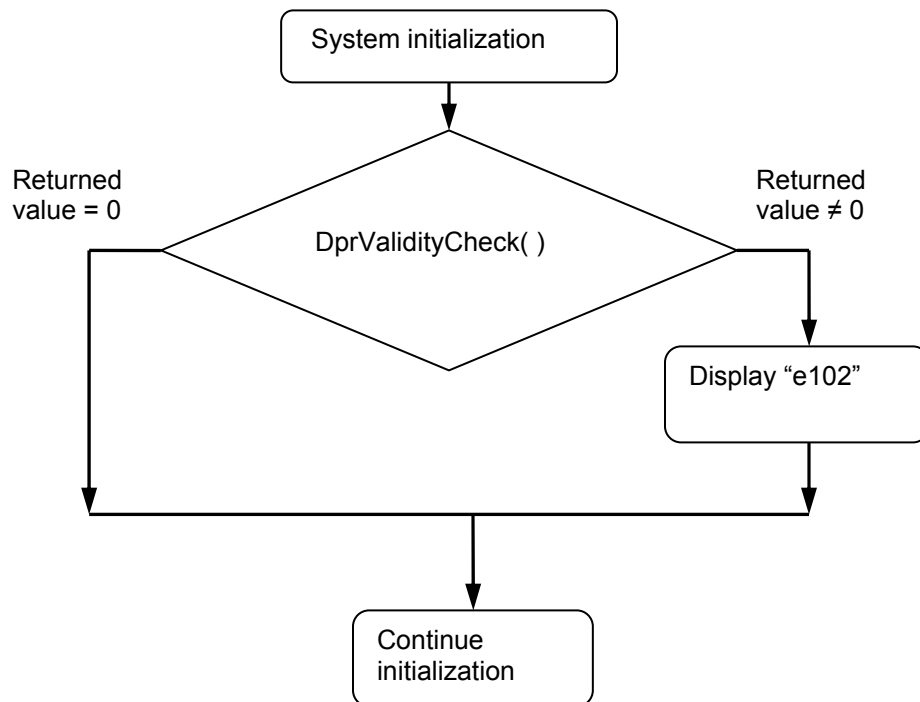
System initialization program call “DprValidityCheck” function.

If returned value is NOT equal to zero then indicate that the DPRAM validity check failed. Display “e102” error and continue.

This function checks read/write validity of each bit of the DPRAM first block words (one by one). After all read/write operations with word the last result should be ZERO. It's a sign that all 16 bits of this word passed read/write validity and function can check next word. If result is greater than ZERO the function is stopping and returning this value. In this way function checks all 256 words of the DPRAM first block.

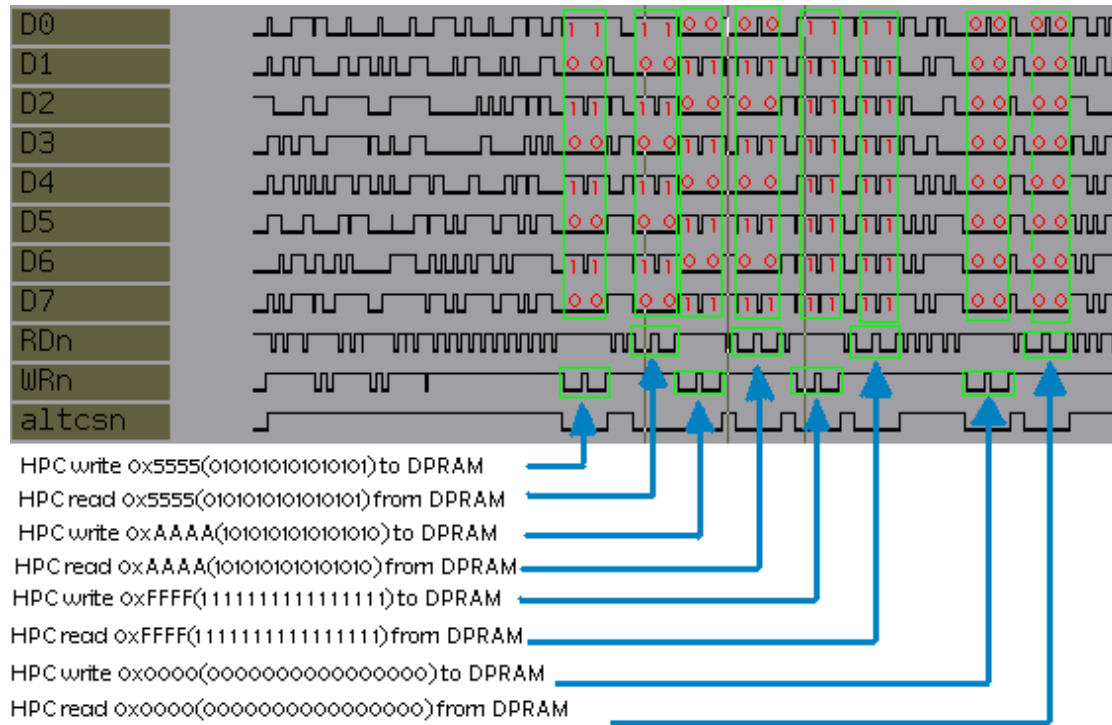
#### “DprValidityCheck” review:

1. HPC write 0x5555 to DPRAM start address (0xE800).
2. HPC read value from DPRAM (should be 0x5555) and then write 0xAAAA to DPRAM.
3. HPC read value from DPRAM (should be 0xAAAA) and add to previous value (0x5555). Result should be 0xFFFF.

4. HPC write calculated value to DPRAM.
5. HPC read value from DPRAM (should be 0xFFFF) and complement received value.
6. HPC check if value greater than zero.
7. If greater, jump to end and return last value.
8. Else write this value (0x0000) to DPRAM.
9. HPC read value from DPRAM (should be 0x0000).
10. HPC check if value greater than zero.
11. If greater, jump to end and return last value.
12. Else go to next DPRAM word check.
13. HPC check in this way all 256 words.
